MFJ 913 Balun Repair

Bob Beanblossom WA4JIT

March 2021

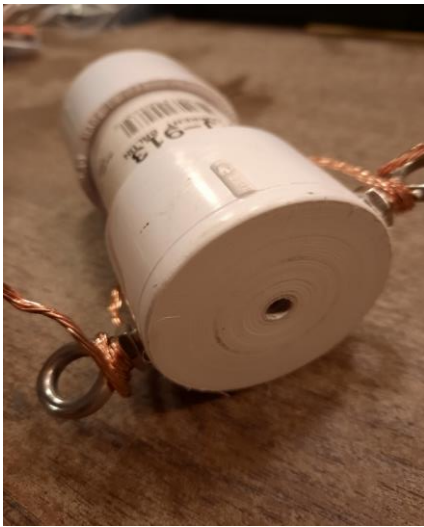
Photo 1

Rather than build my own, I opted to buy an MFJ 913 4:1 balun for my OCF antenna. After soldering the antenna legs to the leads on the balun, I hooked the top eyebolt to my line and hoisted it up the tower. Well, that was the plan. As the assembly almost reached the mounting height the entire array fell back to the ground. The hoisting line remained connected at the top. The factory eyebolt on the top of the balun had come out. See Photo 1.

The balun is housed in a section of PVC pipe with caps on either end—all securely glued. An inexpensive solution to house the balun and support the wire antenna.

The eyebolt came out because the nut inside the “box” came off. Although it had a jam nut on the outside and a lock washer, apparently all had not been securely tightened at the factory. Once loose, there was nothing to stop the nut from coming off.

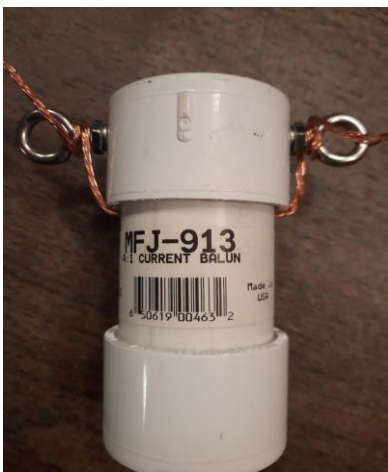
The first challenge was how to get into the box in such a way as to allow it to be securely reassembled. The only way in was to cut the pipe in what I hoped would not damage essential parts. I knew what was inside electrically but not physically. Photo 2 shows the exterior.

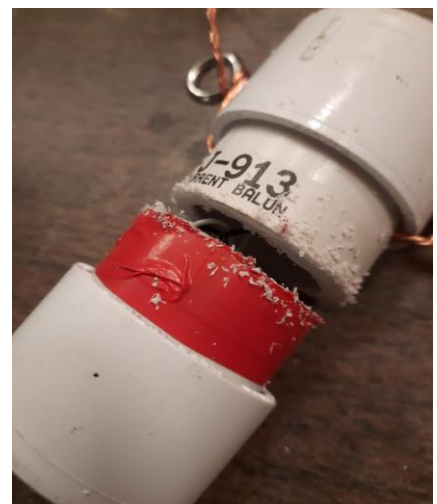
Photo 3

I decided to repair the cut pipe with a sleeve. After that, I simply took a chance and cut the pipe in the middle to allow room on top and bottom to glue the sleeve. See Photo 3.

The cut worked well and no component was damaged. The UHF connector at the bottom had suggested that all the “guts” were in the lower portion of the box, and they were. Only the lead wires to the side mounted eyebolts for the antenna-balun interface were in the top portion.

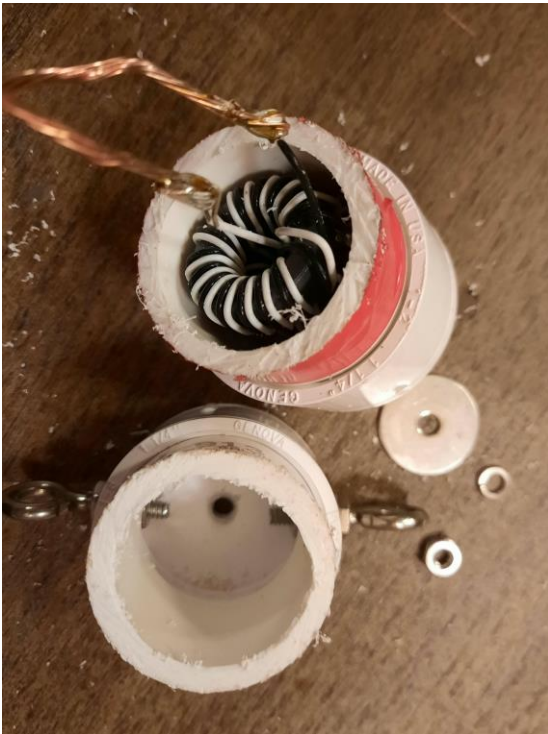
Photo 4

The cut worked well (photo 4) and the “guts” are seen in the top of the picture which is the bottom of the balun where the coax attaches. The hardware to the right of the box is the reinforcing fender washer, lock washer, and standard nut. The side eyebolts are attached the same way. The problem is that if the nut becomes loose, there is no way to tighten it and prevent ultimate failure.

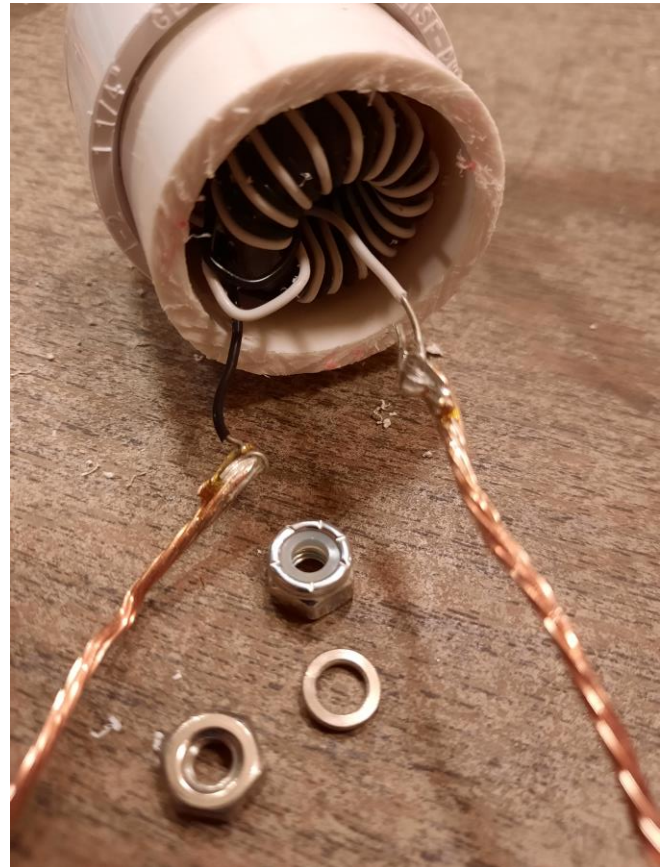
This photo also shows what I consider to be another shortcoming. The leads to the antenna eyebolt are not insulated. Once routed through the holes below the proper eyebolts and the whole system is secured by glue, and the wires are wrapped around the eyebolt, the problem of shorting the leads during reassembly nor use is minimized, but again, a little work and expense on the front end prevents problems later.

My solution was to replace all of the standard nuts with nyloc nuts that do not rely on the lock washer to maintain integrity of the connection. Photo 5 shows the new nyloc and a standard nut. The added cost is negligible for the benefits achieved.

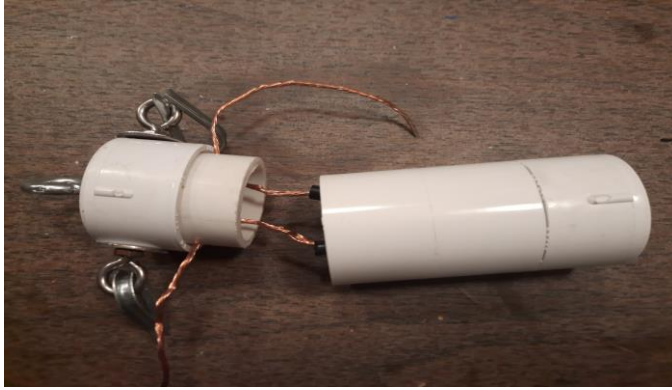
Photo 7 shows the careful process of feeding the wires through the holes as the whole assembly is worked together. This is no time to rush, and when close, PVC cement can be applied with no danger of drying before final assembly. Note that the heat shrink will insulate the leads right up to the feed holes.

I simply slipped some heat shrink over each lead before routing them back out the holes by the feed eyebolts. The length is determined by the distance from the ferrite core to the exit holes. This fix is visible in photos Photos 6 and 7.

I installed the 1 ¼” PVC sleeve over the cut pipe and after routing the leads through the existing holes. The whole thing is reassembled as the leads while fishing the leads through the holes, keeping them snug without adding unnecessary pressure on the ferrite donut. All PVC joints are glued with the proper PVC cement. Don’t be skimpy with the cement. These joints will support the apex of the entire antenna assembly.

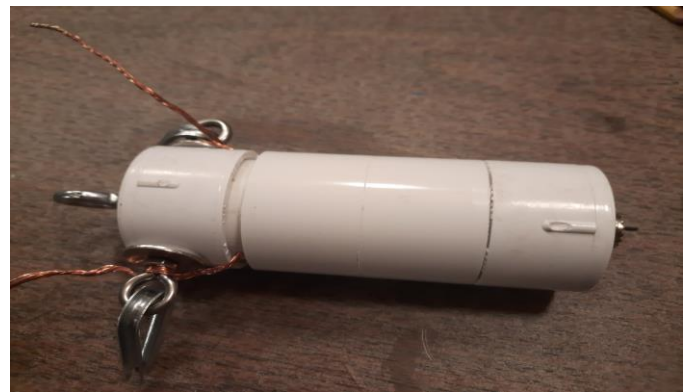
Photo 8 shows the completed repair. The sleeve has been securely glued in position after the feed wires were snaked through the existing holes.

An added feature is the addition of a fender washer on the outside of the box as reinforcing to minimize wear at these vital junctions. Again, minimal cost and effort for an added layer of security.
